Briefing on Bay Bridge Bolts - May 29, 2013

1. What caused the E2 anchor bolts manufactured in 2008 to fail?

Metallurgical Report on 2008 Bolts, Dated May 7, 2013

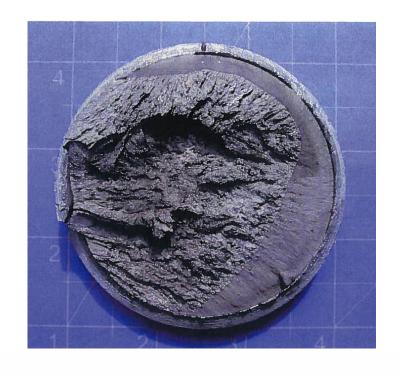
- The root cause of the failures is attributed to higher than normal susceptibility of the steel to hydrogen embritlement.
- The metallurgical condition of the 2008 bolts was found to be less than ideal with large differences in hardness from center to edge, and high local hardness near the surface. The material also exhibited low toughness and marginal ductility.
- The combination of all of these factors caused the 2008 anchor rods to fail due to hydogen embrittlement.

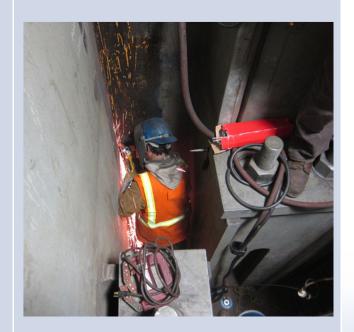
- 1. Electroslag Welding at Tower Base
 - Inspectors have found a number of imperfections in electroslag welds at the base of the tower.
 - Engineers are methodically mapping welds and determining which imperfections must be removed and replaced with quality weld material to ensure that all weld capacities exceed seismic demands for the 1,500 year design motions.
 - The process has been underway for about nine months, and is continuing.

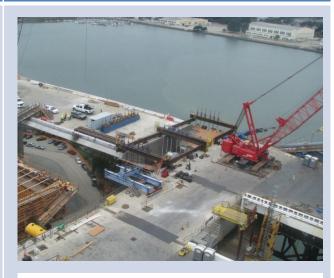
5. YBI/SAS Deck Alignment

- The concrete section of the bridge between the Self-Anchored Suspension span and Yerba Buena Island was a few inches higher than the suspension bridge deck. The added elevation was the due to the pulling forces of the imbedded pre-stressing tendons.
- Engineers carefully considered several options.
- The steel ballast option was selected as best alternative.
